## **Appendix C**

## **Thermal Imaging**

**North Haven Congregational Church**

28 Church Street  
North Haven, Connecticut 06473

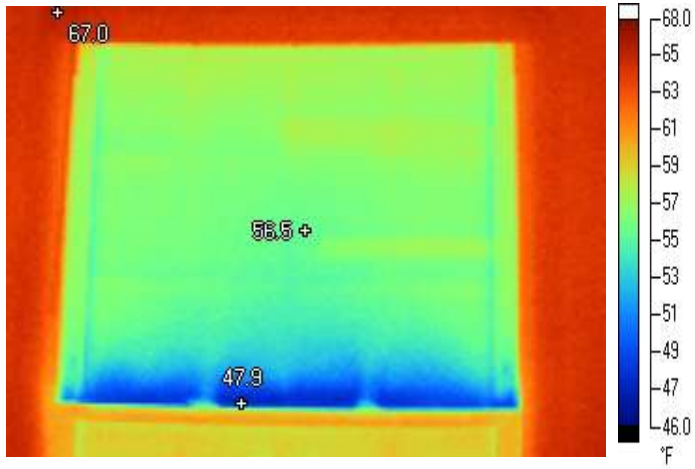
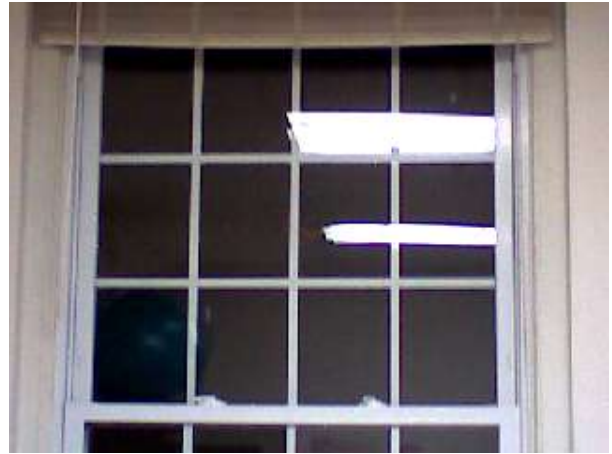
**Music Room.IS2**

Label	Temperature	Emissivity	Background
Centerpoint	56.5 °F	0.95	71.6 °F
Hot	67.0 °F	0.95	71.6 °F
Cold	47.9 °F	0.95	71.6 °F

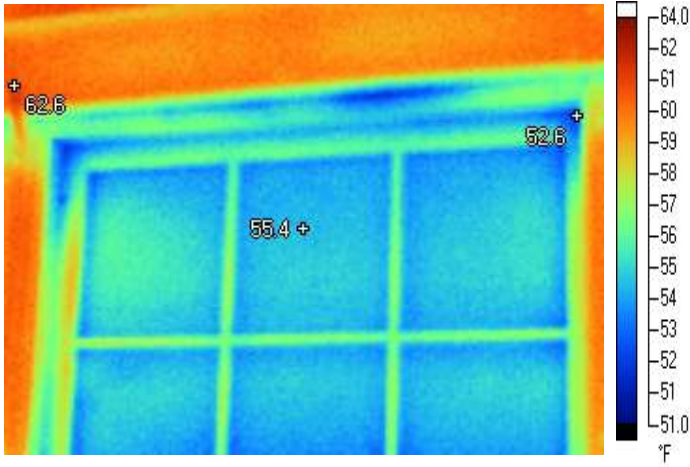
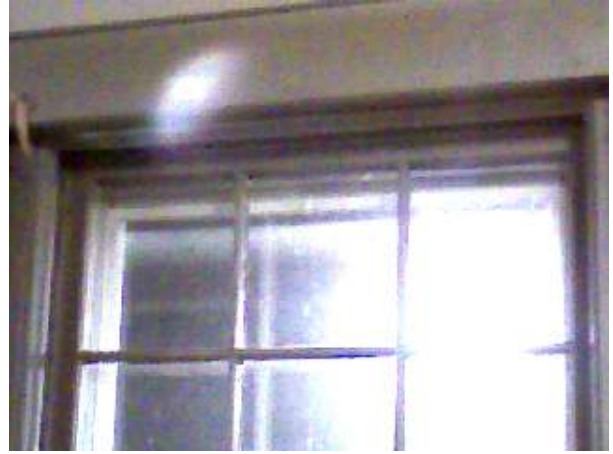
**Rear Stairwell.IS2**

Label	Temperature	Emissivity	Background
Centerpoint	55.4 °F	0.95	71.6 °F
Hot	62.6 °F	0.95	71.6 °F
Cold	52.6 °F	0.95	71.6 °F

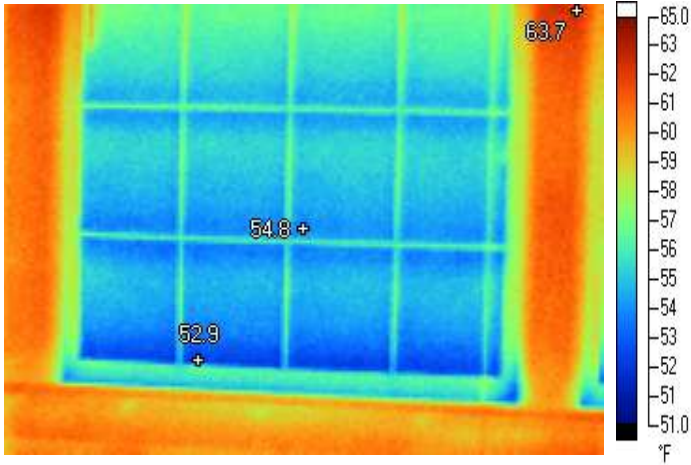
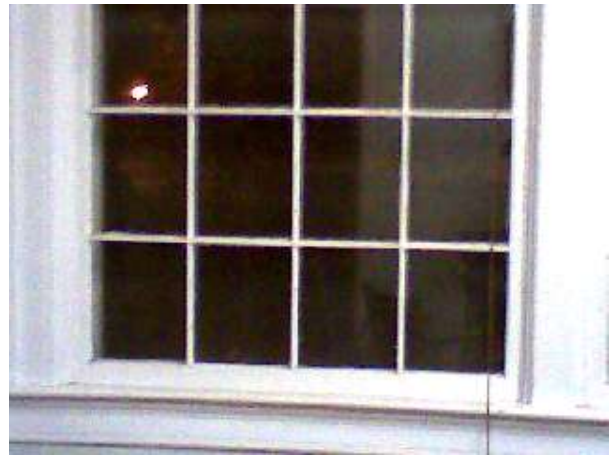
**Heath Room.IS2**

Label	Temperature	Emissivity	Background
Centerpoint	54.8 °F	0.95	71.6 °F
Hot	63.7 °F	0.95	71.6 °F
Cold	52.9 °F	0.95	71.6 °F

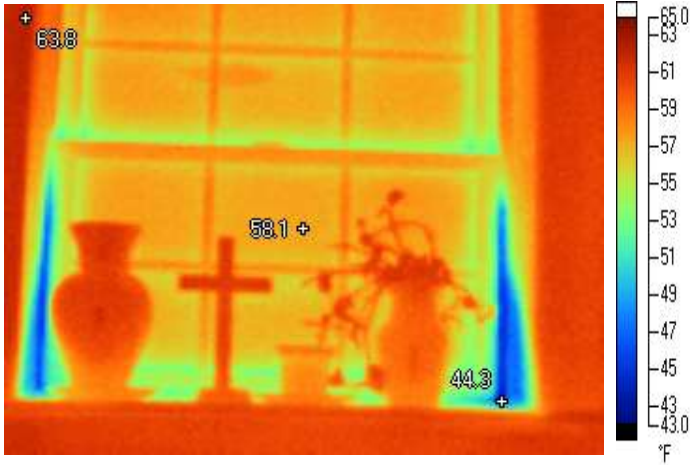
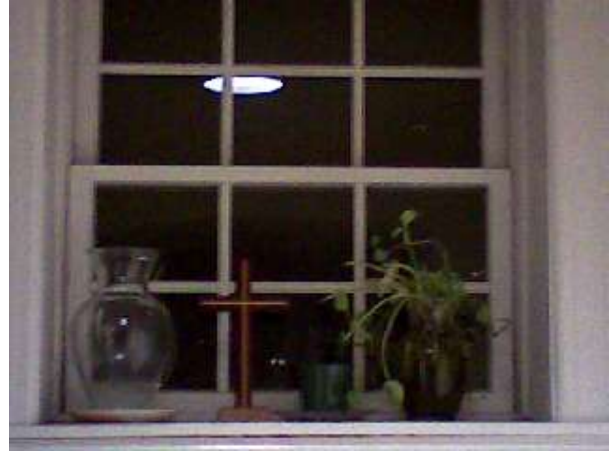
**Elevator Entrance.IS2**

Label	Temperature	Emissivity	Background
Centerpoint	58.1 °F	0.95	71.6 °F
Hot	63.8 °F	0.95	71.6 °F
Cold	44.3 °F	0.95	71.6 °F

Weather stripping on exterior doors should be replaced or adjusted.

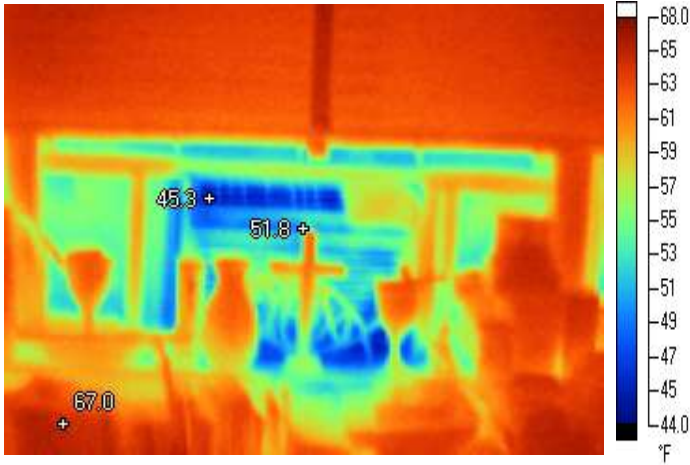
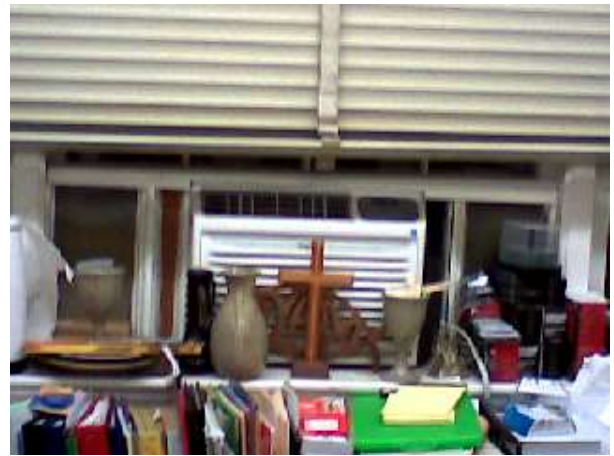
**Minister's Office.IS2**

Label	Temperature	Emissivity	Background
Centerpoint	51.8 °F	0.95	71.6 °F
Hot	67.0 °F	0.95	71.6 °F
Cold	45.3 °F	0.95	71.6 °F

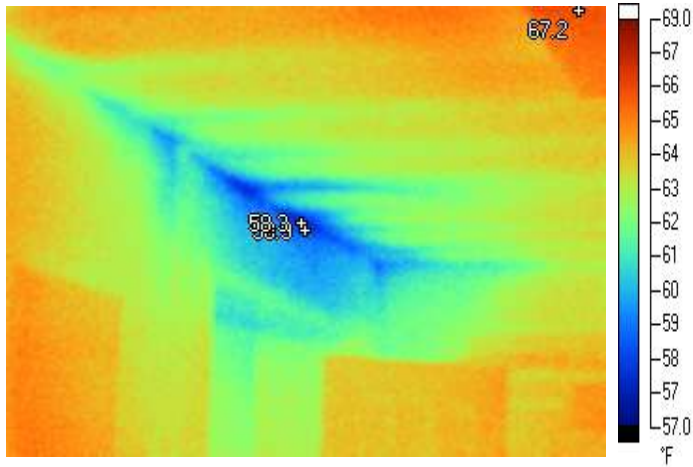
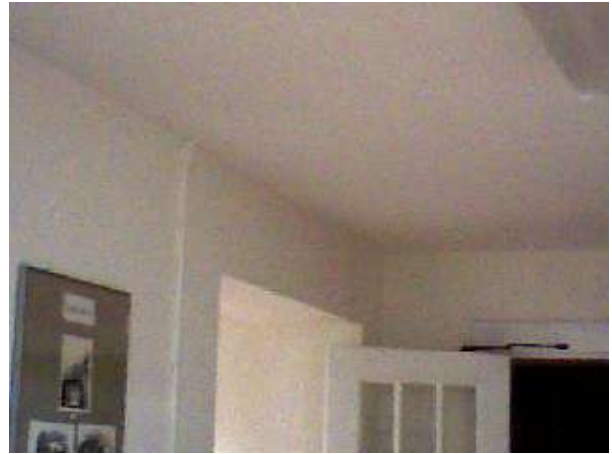
**Hallway.IS2**

Label	Temperature	Emissivity	Background
Centerpoint	58.9 °F	0.95	71.6 °F
Hot	67.2 °F	0.95	71.6 °F
Cold	58.3 °F	0.95	71.6 °F

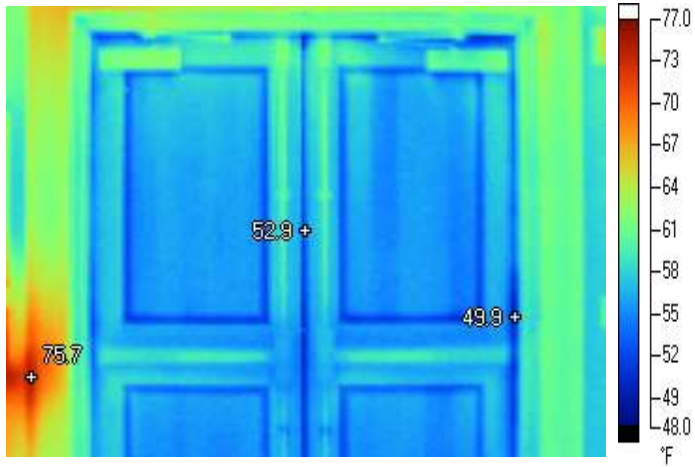
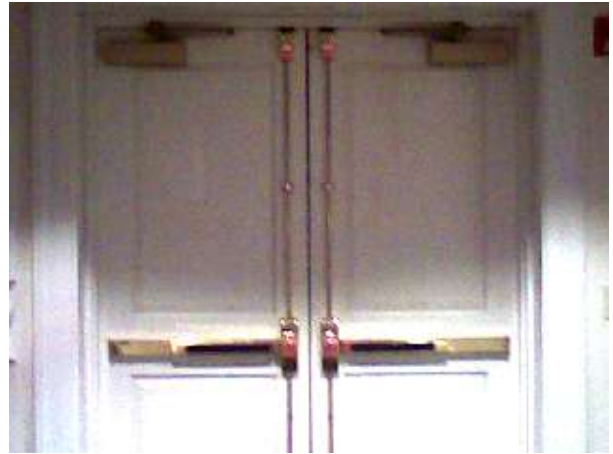
**Narthex.IS2**

Label	Temperature	Emissivity	Background
Centerpoint	52.9 °F	0.95	71.6 °F
Hot	75.7 °F	0.95	71.6 °F
Cold	49.9 °F	0.95	71.6 °F

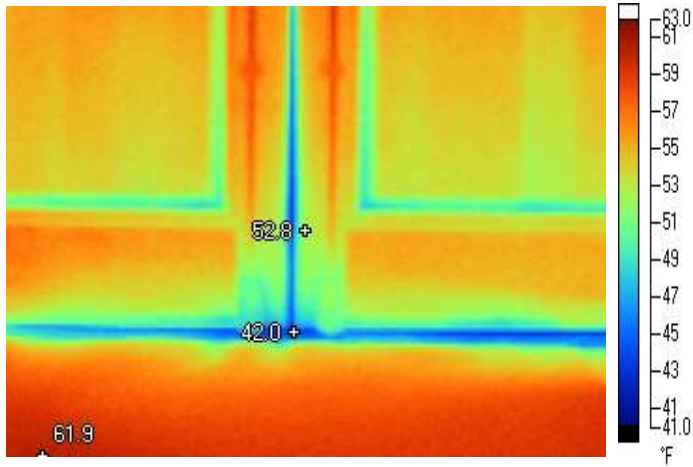
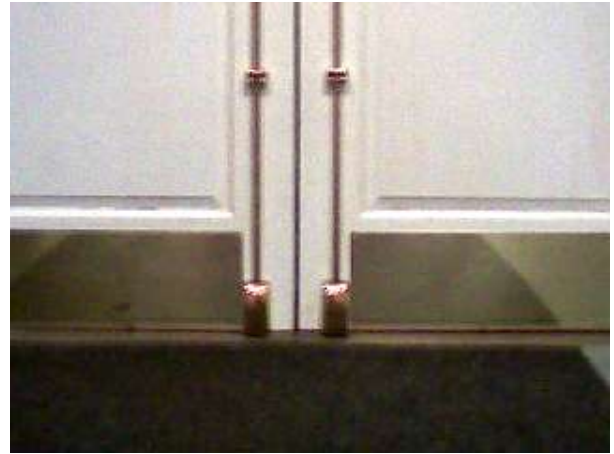
**Front Entrance Doors.IS2**

Label	Temperature	Emissivity	Background
Centerpoint	52.8 °F	0.95	71.6 °F
Hot	61.9 °F	0.95	71.6 °F
Cold	42.0 °F	0.95	71.6 °F

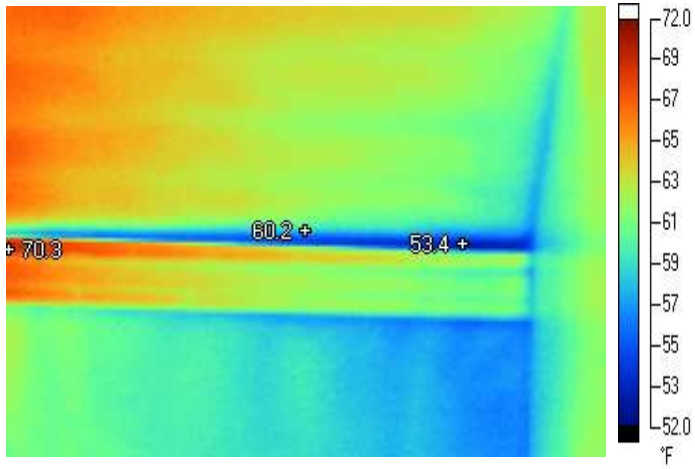
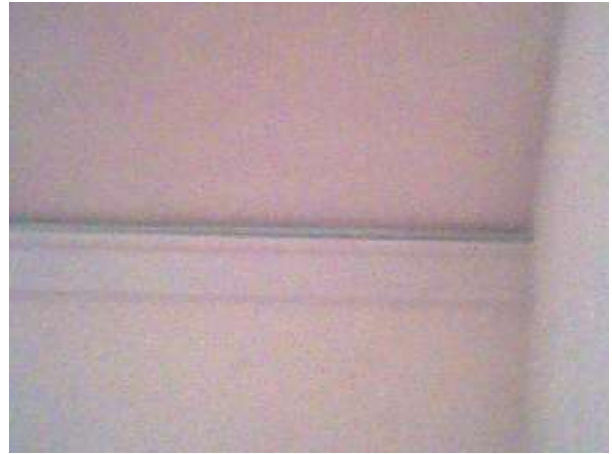
**Nave Ceiling 2.IS2**

Label	Temperature	Emissivity	Background
Centerpoint	60.2 °F	0.95	71.6 °F
Hot	70.3 °F	0.95	71.6 °F
Cold	53.4 °F	0.95	71.6 °F

Wall and ceiling construction have limited quantities of insulation.

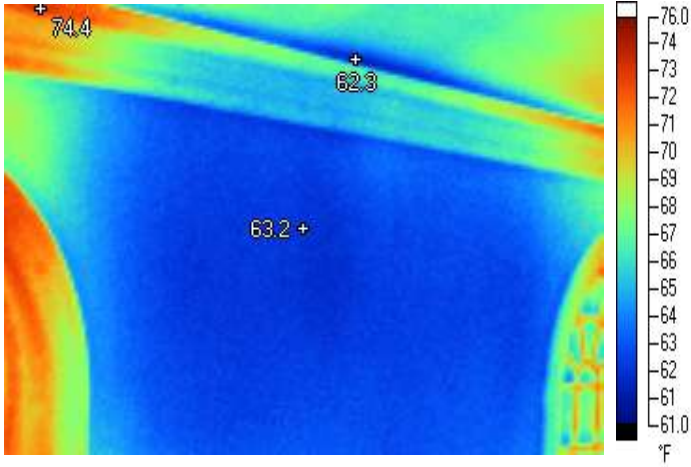
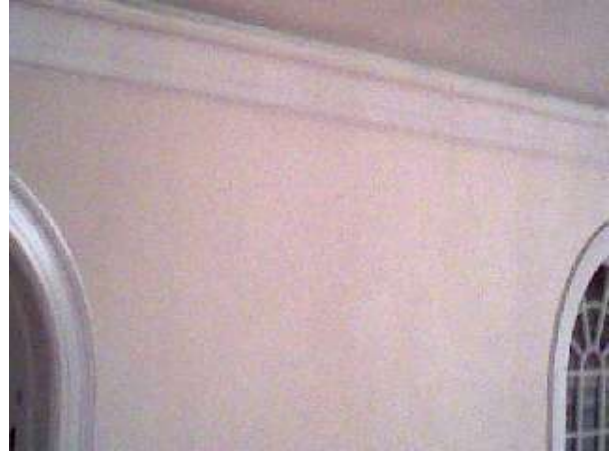
**Nave Windows.IS2**

Label	Temperature	Emissivity	Background
Centerpoint	63.2 °F	0.95	71.6 °F
Hot	74.4 °F	0.95	71.6 °F
Cold	62.3 °F	0.95	71.6 °F

There is air leakage along the perimeters of old windows.

New replacement windows have better thermal resistance. However, there is still air leakage around the sash and sill.

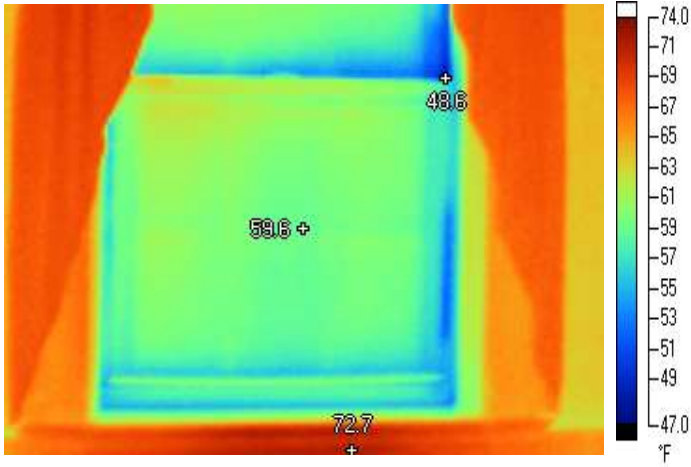
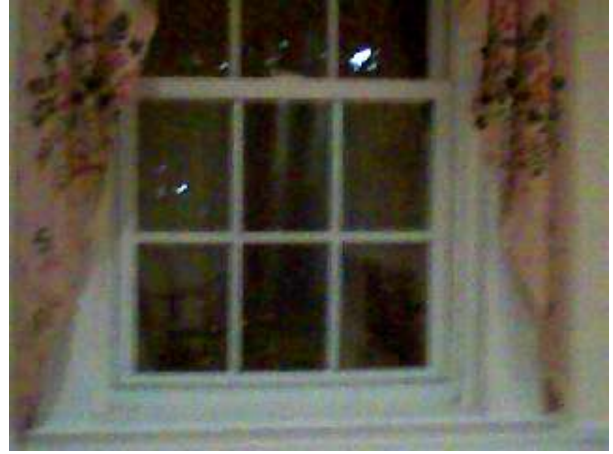
**Library.IS2**

Label	Temperature	Emissivity	Background
Centerpoint	59.6 °F	0.95	71.6 °F
Hot	72.7 °F	0.95	71.6 °F
Cold	48.6 °F	0.95	71.6 °F

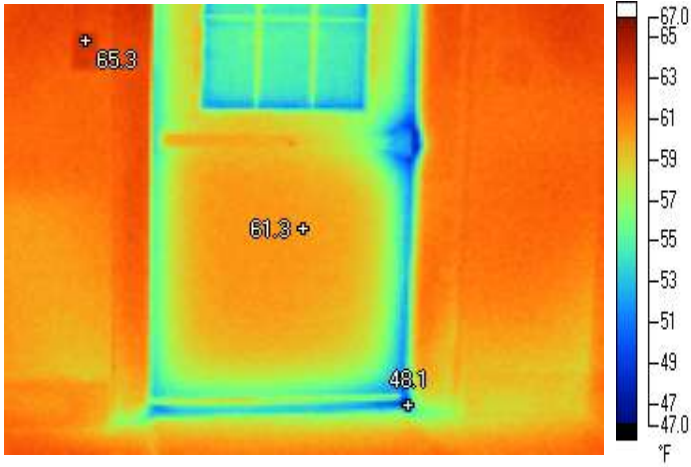
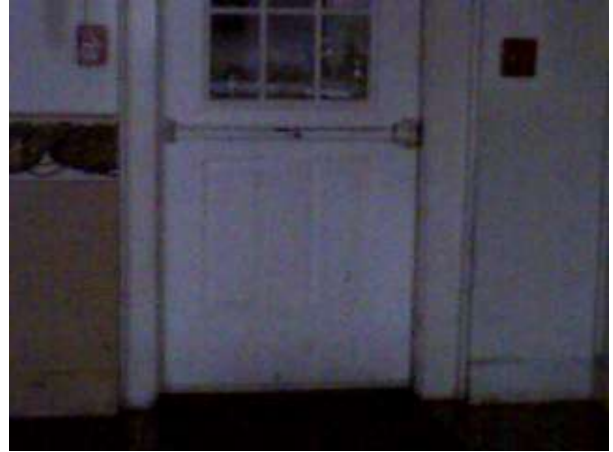
**Exit Door Carroll Hall.IS2**

Label	Temperature	Emissivity	Background
Centerpoint	61.3 °F	0.95	71.6 °F
Hot	65.3 °F	0.95	71.6 °F
Cold	48.1 °F	0.95	71.6 °F

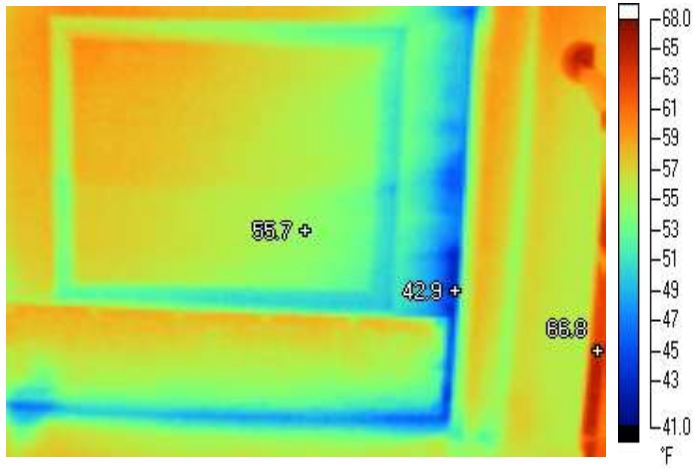
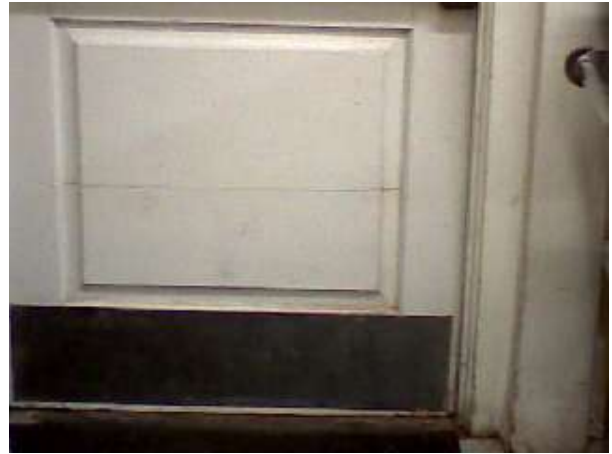
**Kitchen Door.IS2**

Label	Temperature	Emissivity	Background
Centerpoint	55.7 °F	0.95	71.6 °F
Hot	66.8 °F	0.95	71.6 °F
Cold	42.9 °F	0.95	71.6 °F

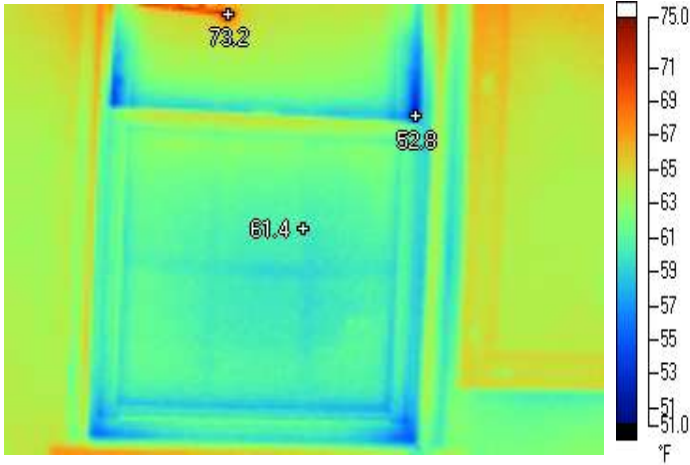
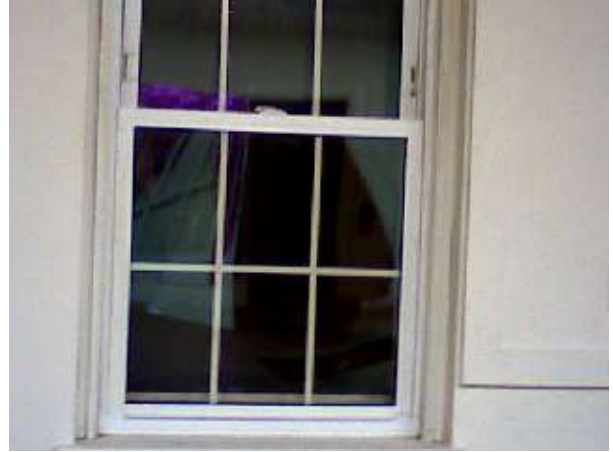
**Lower Level Classroom.IS2**

Label	Temperature	Emissivity	Background
Centerpoint	61.4 °F	0.95	71.6 °F
Hot	73.2 °F	0.95	71.6 °F
Cold	52.8 °F	0.95	71.6 °F

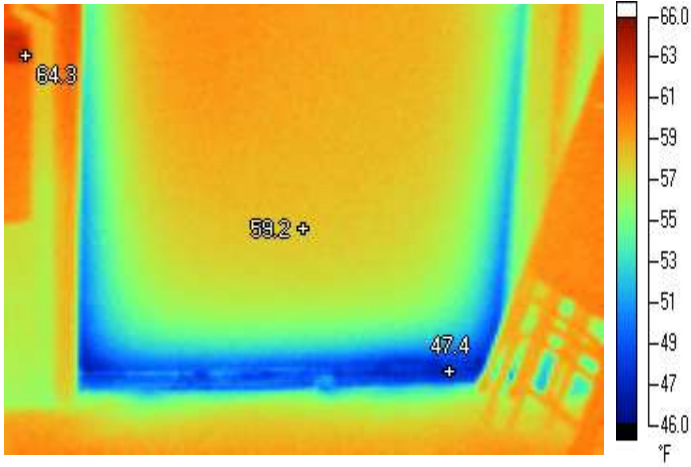
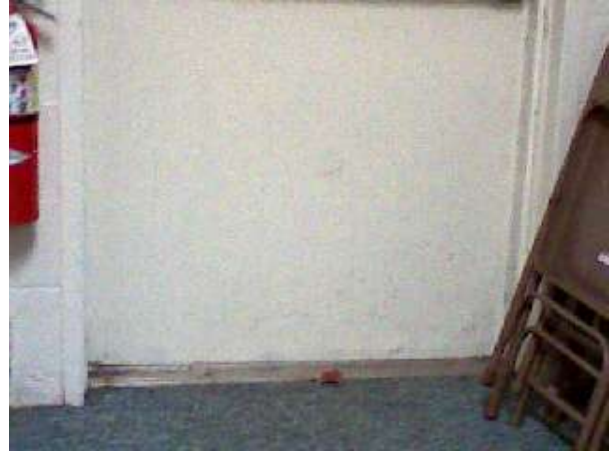
**Lower Level Exit Door.IS2**

Label	Temperature	Emissivity	Background
Centerpoint	59.2 °F	0.95	71.6 °F
Hot	64.3 °F	0.95	71.6 °F
Cold	47.4 °F	0.95	71.6 °F

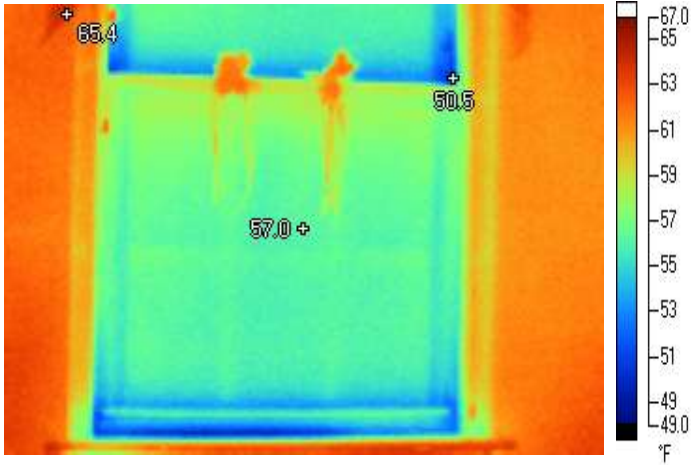
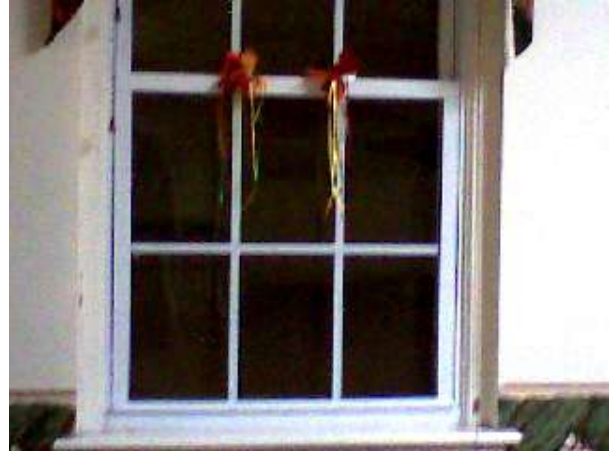
**Carroll Hall.IS2**

Label	Temperature	Emissivity	Background
Centerpoint	57.0 °F	0.95	71.6 °F
Hot	65.4 °F	0.95	71.6 °F
Cold	50.5 °F	0.95	71.6 °F

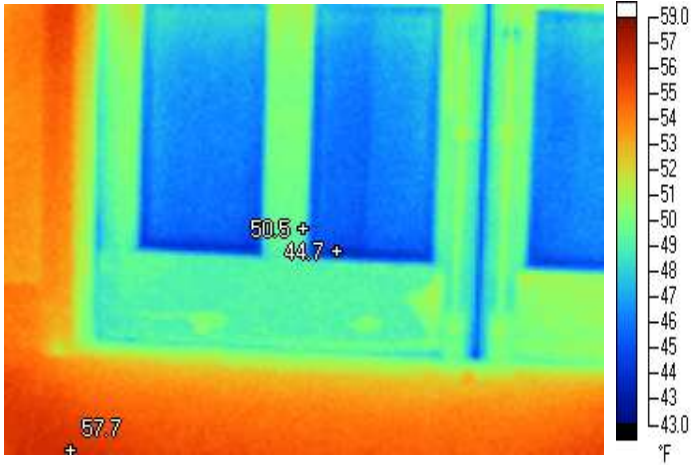
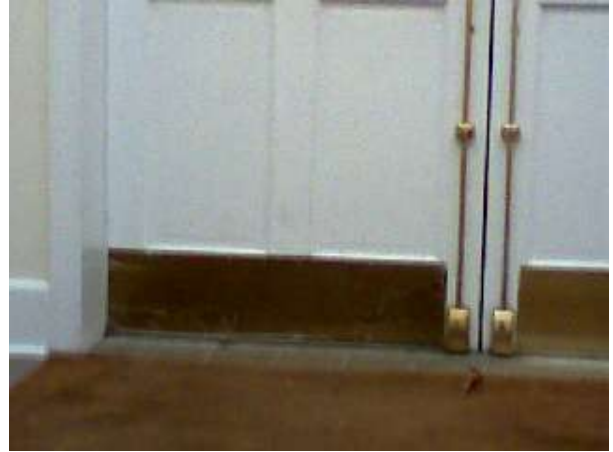
**Elevator Lobby Doors.IS2**

Label	Temperature	Emissivity	Background
Centerpoint	50.5 °F	0.95	71.6 °F
Hot	57.7 °F	0.95	71.6 °F
Cold	44.7 °F	0.95	71.6 °F

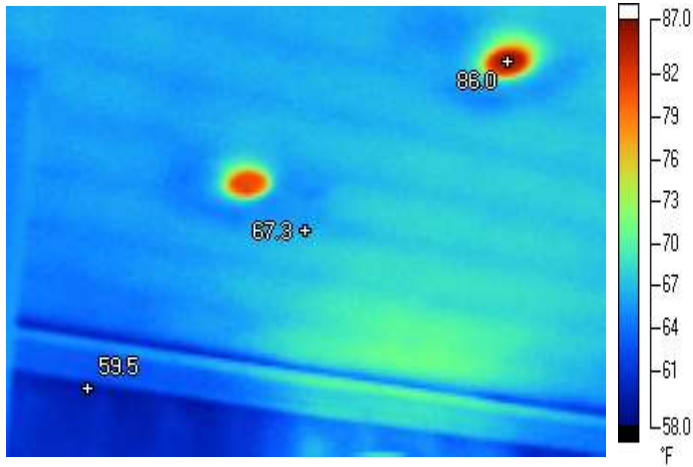
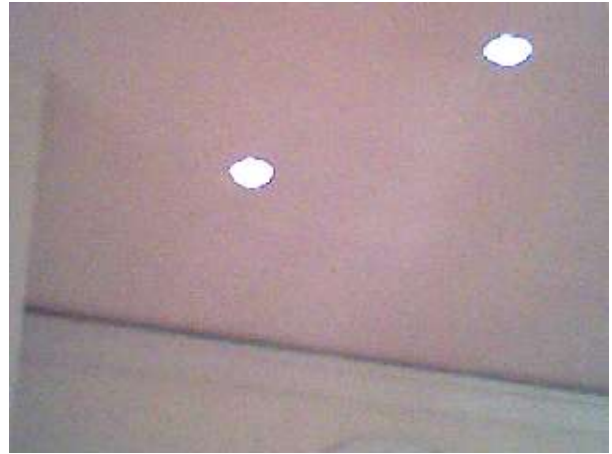
**Nave Ceiling 3.IS2**

Label	Temperature	Emissivity	Background
Centerpoint	67.3 °F	0.95	71.6 °F
Hot	86.0 °F	0.95	71.6 °F
Cold	59.5 °F	0.95	71.6 °F

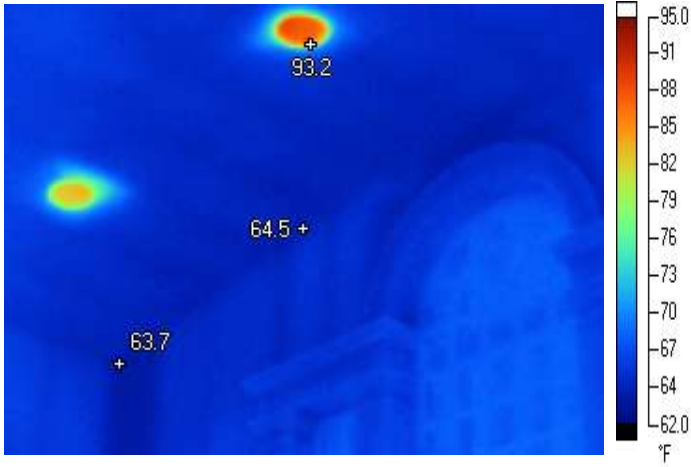
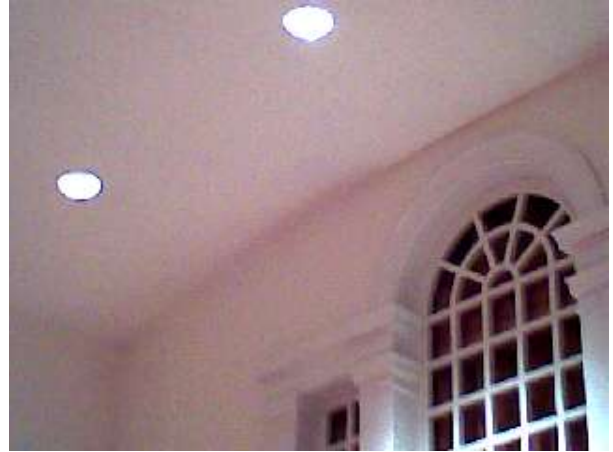
**Sanctuary Ceiling3.IS2**

Label	Temperature	Emissivity	Background
Centerpoint	64.5 °F	0.95	71.6 °F
Hot	93.2 °F	0.95	71.6 °F
Cold	63.7 °F	0.95	71.6 °F

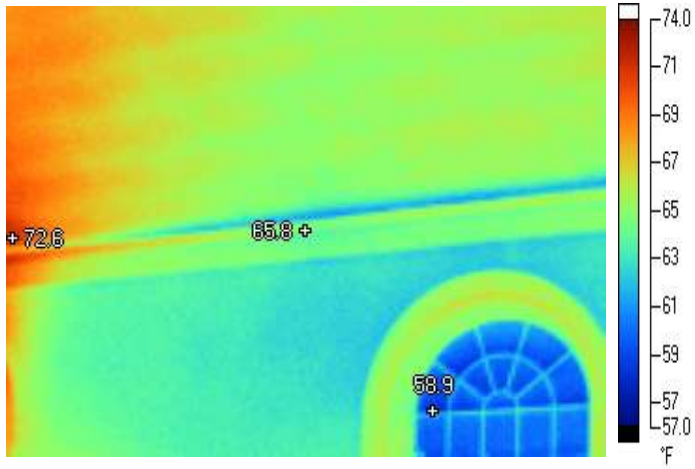
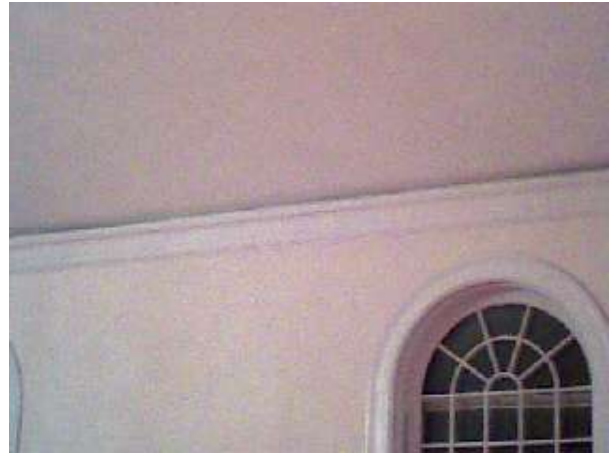
**Nave Ceiling.IS2**

Label	Temperature	Emissivity	Background
Centerpoint	65.8 °F	0.95	71.6 °F
Hot	72.6 °F	0.95	71.6 °F
Cold	58.9 °F	0.95	71.6 °F
